Interstate 90 – Snoqualmie Pass East

VISUAL IMPACT ASSESSMENT DISCIPLINE REPORT

September 2004

**Washington State
Department of Transportation**

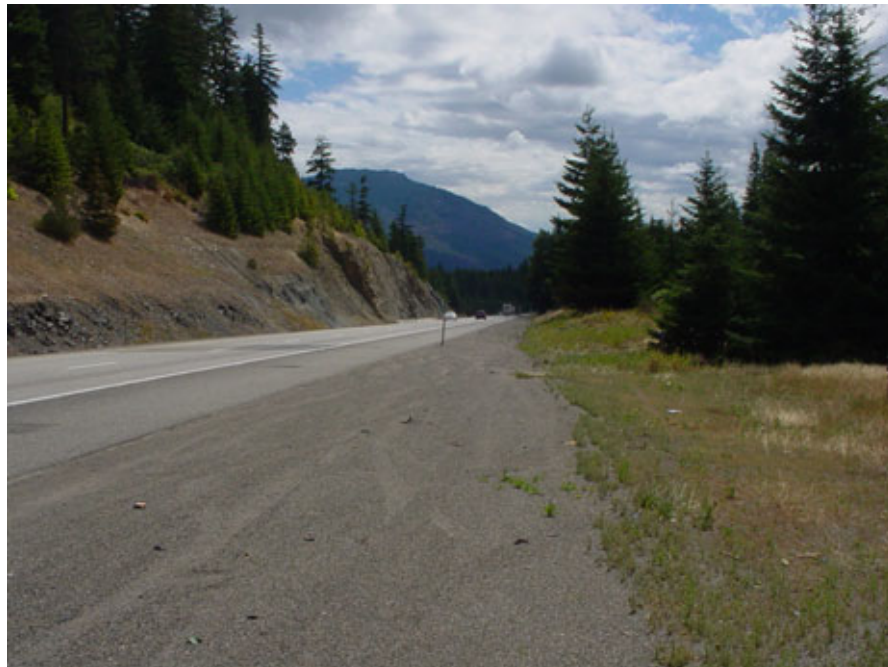
Figure 79 Key View 16 – MP 67.7 – Eastbound

This view illustrates the typical eastbound view in this northern end of Landscape Unit 4. The foreground view is of the road, nearby Douglas fir and cottonwood trees, and the native grasses in the median. Middleground views are of the same mix of trees. The background view is also of trees, with mountain views straight ahead up the centerline of the road. The character of this portion of the roadside can be seen in Figure 79.

The densely vegetated median, the rolling landform, the second-growth trees, and the distant mountain views combine to give this view an average vividness rating. There is little visible development other than the highway. The intactness rating for this scene is high. It also has a high unity rating since the forest seems almost unbroken when seen from a traveling vehicle, and travelers in the westbound lanes are not visible.

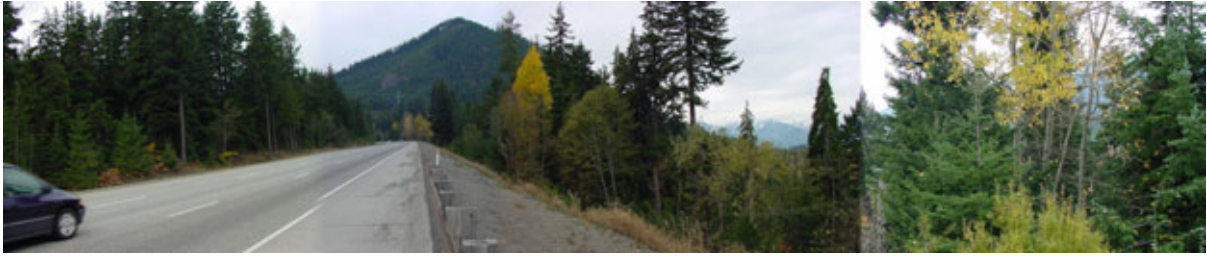
Figure 80 Key View 17 – MP 67.8 – Westbound

The foreground view, in Key View 17, is of roadside vegetation. The middleground view is of the mountain straight ahead. The background view, just right of center, is of mountains in the Alpine Lakes Wilderness.

Key View 17 has a moderately high vividness rating. The contrast between the forest and distant mountain views is very memorable. The highway and the power lines, which can occasionally be seen on the north and straight ahead, are the only signs of development. It has a high intactness rating. The overall unity rating for this scene is high. The total visual quality rating is high. At MP 67.8, there is an excellent, but quick, view up the Kachess Lake Valley to the Alpine Lakes Wilderness. This view, seen in Figure 81, is for information and has not been rated, due to the minimal duration of the view by motorists. This spectacular view is nearly blocked by second growth Douglas fir, Western Hemlock, black cottonwoods, and alders. As these trees mature, the view available will lessen even more.

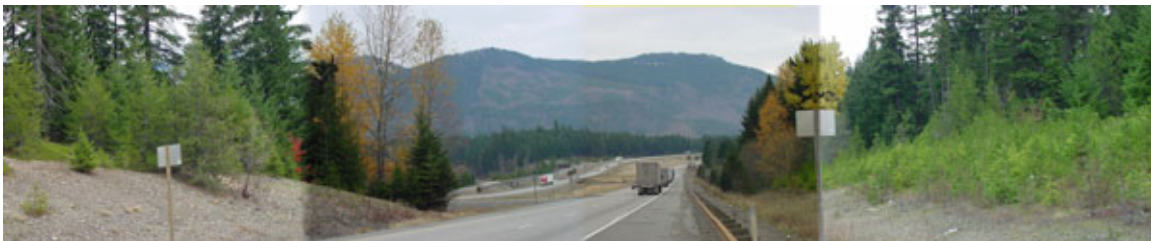
Figure 82 Key View 18 – MP 69 – Eastbound

This view of the southeastern end of the project corridor and of Landscape Unit 4 opens from a forested corridor to a more open landscape. This view has Douglas fir seedlings in the foreground, more mature Douglas firs and cottonwoods in the middleground, and forest-covered mountains in the background. Guardrail divides the roadway from the roadside here instead of the Jersey barrier common in the previous Landscape Units. Figure 82 also shows the backside of traffic signs and their visibility.

This Key View has a vividness rating of just above average, again because of the lack of a water view. The road is the principle sign of development. It has a moderately high intactness rating. Its overall unity rating is moderately high.

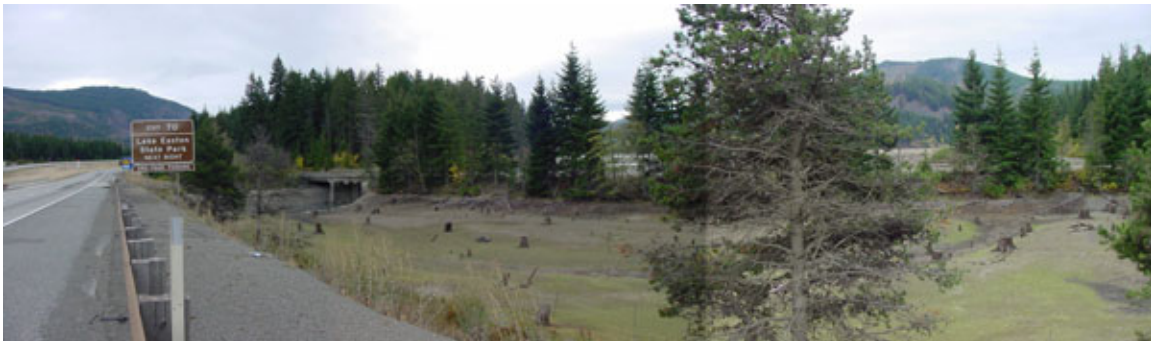
Figure 83 Key View 19 – MP 69.5 – Eastbound – Kachess River CRA

This view is of an arm of the lakebed of Lake Easton between I-90 and the John Wayne Trail. In October 2001, when this photo was taken, it was dry, but commonly this area is covered in water. The foreground is of the guardrail, a struggling Douglas fir, and native grasses. Middleground views are of the lakebed and the Douglas fir forest at the Lake Easton State Park. Background views are of recently logged mountains, as seen in Figure 83.

When lake levels are high, this is a very memorable spot on the drive through the project corridor. There are often children fishing from the bridge. Lake Easton, with its forested shore and the distant, rounded mountains give this a moderately high-to-high vividness rating. Road and traffic signs, and the bridge over the Kachess River are signs of development, and cause some visual encroachment. Key View 19 has a moderately high intactness rating and a high unity rating.

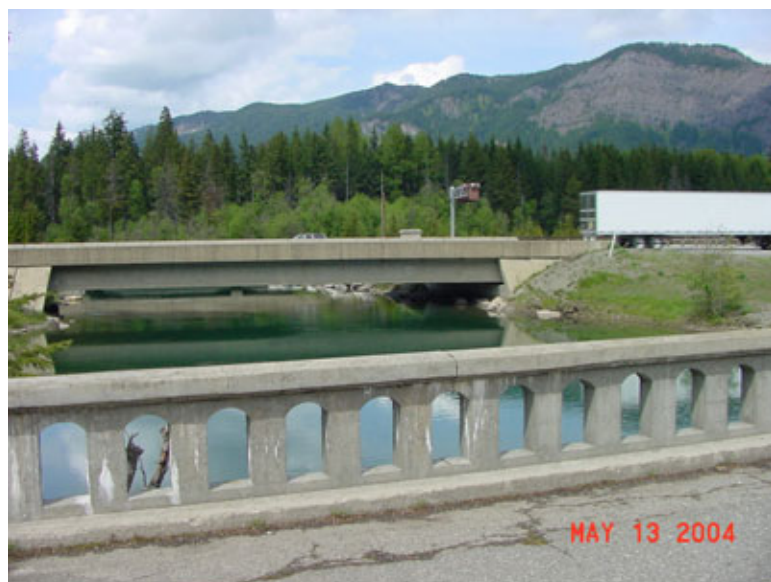
Figure 84 Key View L - Toward I-90 from the Kachess River Bridge at Lake Easton State Park

Key View L was taken in 2004 from the Kachess River bridge located at the Lake Easton State Park. This is a popular bridge for fishing, and is located near camping and picnicking areas. Foreground views are of the old bridge railing and the Kachess River. The middleground view is occupied by I-90's bridge over the Kachess River. Background views are of mountains in the distance.

This scene has a water view, forested hills, and distant mountains. It has a moderately high-to-high vividness rating. The bridge in the middleground and the steep slopes are signs of development, as is the highway in the background. The intactness rating is moderately high. The road disrupts the unity of this view for a rating of average.

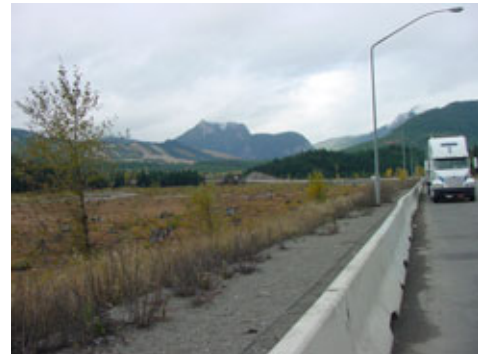
Figure 86 Key View 1

The chain-off areas would be lengthened along this portion of roadway with increased lighting provided. Options for Gold Creek CRA provide new and various sized structures ranging from 300 feet to 1200 feet in length. These will be visible from this location. Because the roadside will be moved toward the lake and the roadside will be planted, vividness scores for vegetation and water are expected to rise above current levels. Total Visual Quality Ratings for this Key View are found in Table 3.

Key View 1 –MP 56 – Westbound – Gold Creek CRA – Total Visual Quality Ratings	
<i>Alternatives</i>	<i>Rating</i>
Existing (No Build)	4.92
Improvement Package A	5.67
Improvement Package B	5.46
Improvement Package C	5.25

After project completion, visual quality ratings will highest for option A because of the removal of fill and the expanded opportunity for increased revegetation. As the opportunity for stream meander and replanting lessens, vividness ratings decrease. With revegetation all options are expected to have higher visual quality ratings that the existing condition.

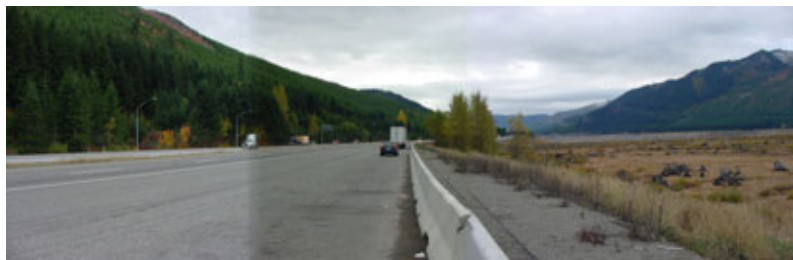
Figure 87 Key View 2

The chain-off areas would be lengthened in the alternatives for this portion of roadway. There would be increased lighting, and, as in Key View 1, the horizontal alignment shifts toward the lakebed. There could be potential distant views of new bridges. Revegetation after roadway construction will improve scores for vegetation, making an overall improvement in visual quality.

Key View 2 –MP 56 – Eastbound – Rocky Run Creek CRA – Total Visual Quality Ratings	
<i>Alternatives</i>	<i>Rating</i>
Existing (No Build)	5.25
Single Ecological Connectivity option	5.50

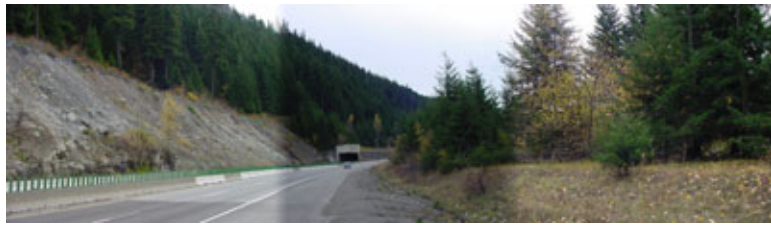
Figure 88 Key View 3

This Key View is taken from the location where there are significant differences in the alignment of I-90 under the different Keechelus Lake Alignment Alternatives. At the present time, the snowshed is in view over the westbound lanes. The alternatives and their impacts are described as follows:

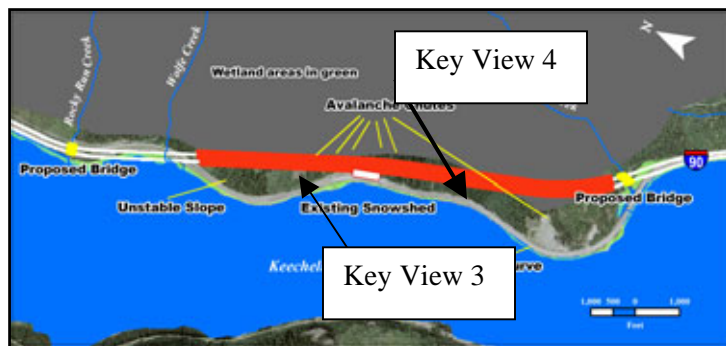
Figure 89 Alternative 1: Long Tunnels

Twin bridges approximately 120 feet long are proposed at Rocky Run Creek, allowing for riparian revegetation. From this Key View, traveler will be inside the tunnel. Views of the mountains, the lake, and vegetation will be non-existent while in the tunnel. Because of this, visual quality at this location would be moderately low. The portion of the roadway along Keechelus Lake rendered obsolete by the tunnel would be removed and revegetated.

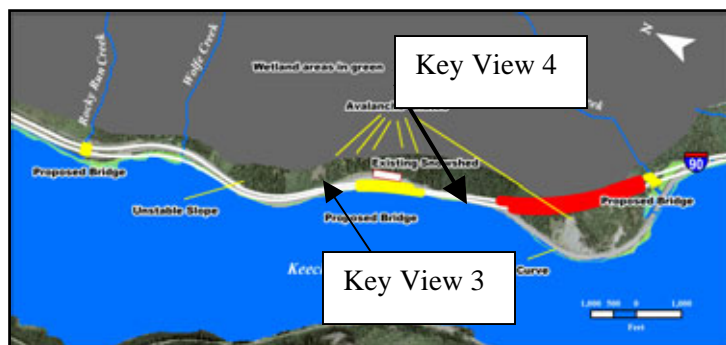
Figure 90 Alternative 2: Short Tunnels

Under Alternative 2, Key View 3 will still have views of the lake. The snowshed would be removed and a new bridge constructed to allow avalanches to pass below the bridge. This bridge will improve sight distance and bring the traveler closer to the lake. There would be an increase in views of the water, which will increase visual quality ratings at this location. There would be retaining walls between the lake and the eastbound lanes. Westbound lanes would be raised above the eastbound lanes and supported by retaining walls. Because of their high visibility, walls will be designed using the Architectural Guidelines. Message reader boards and traffic lights would be installed in front of the tunnel entrance to warn travelers of problems ahead. The existing roadway around Slide Curve would be removed and vegetation restored.

Closer views of the lake, increased vegetation, and the use of the Architectural Guidelines on tunnel portals will result in higher vividness ratings than existing conditions.

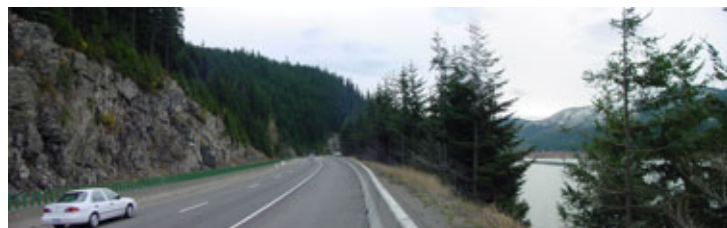
Figure 93 Key View 4

Key View 4 will be within the long tunnel, should Alternative 1 be selected. Alternative 1 will have lower visual quality ratings from the road, than other alternatives, because of the loss of views of the lake and forest-covered mountains. The entrance to the Short Tunnel Alternative would be directly ahead in this view. The alignments and discussion described within Key View 3 apply to this Key View. The Resort Creek improvements are part of the Keechelus Lake Alignment Alternatives, but are out view at this point.

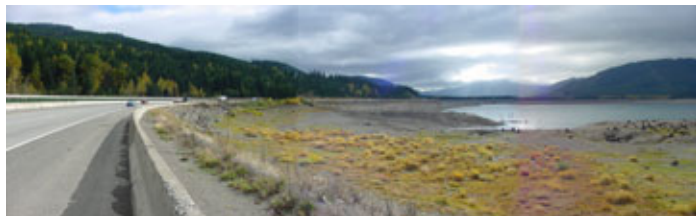
Figure 94 Key View 5

Key View 5 looks southward along Keechelus Lake. The tunnel entrance and exit are behind the viewer. This Key View shows the Resort Creek CRA and the Keechelus Lake shoreline. Any changes to the roadway due to connectivity alterations will show in this Key View. The Resort Creek improvements are part of the Keechelus Lake Alignment Alternatives.

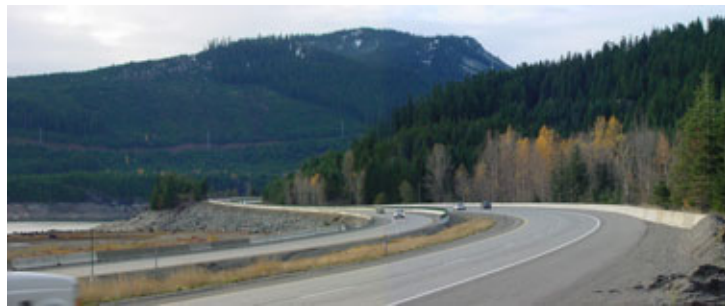
Figure 95 Key View 6

All tunnel alternatives have the tunnel entrance/exit at this location. The sinuosity of the existing road alignment provides visual interest. This will change depending upon the Keechelus Lake Alignment Alternative chosen. The existing 6-foot corrugated metal culverts at Resort Creek would be replaced by a single-span bridge (120-feet long x 10-feet high) in the westbound lanes, and a series of large-span (10-foot to 30-foot span) bottomless culverts in the eastbound lanes that will provide for fish passage at all reservoir pool-levels. Architectural Guidelines will be used on the face of the culverts, so culverts seen from this viewpoint will carry a consistent theme, together with bridge and wall detailing, along the corridor.

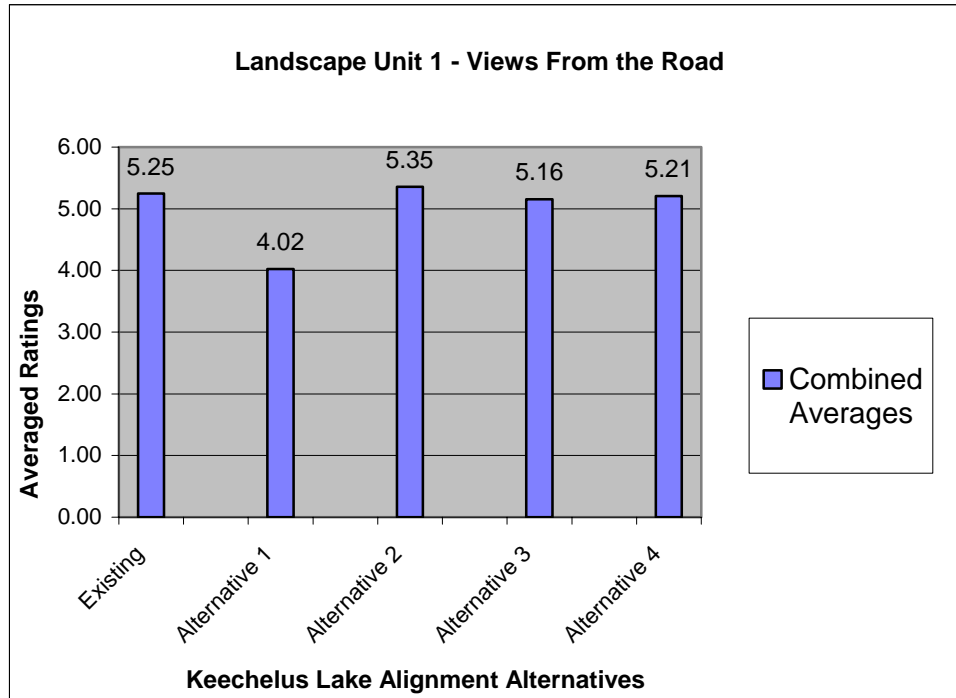
The chart in Figure 96 compares the averages of all ratings for the Keechelus Lake Alignment Alternatives. Ratings from Key Views 3, 4, 5, and 6 were used to determine total visual quality averages for each alignment alternative. Within Landscape Unit 1 for views From the road, Alternative 2 has the highest visual quality ratings, followed by the Existing Condition and Alternative 4.

Figure 96 Landscape Unit 1 – Comparison of Keechelus Lake Alignment Alternatives – Views from the Road

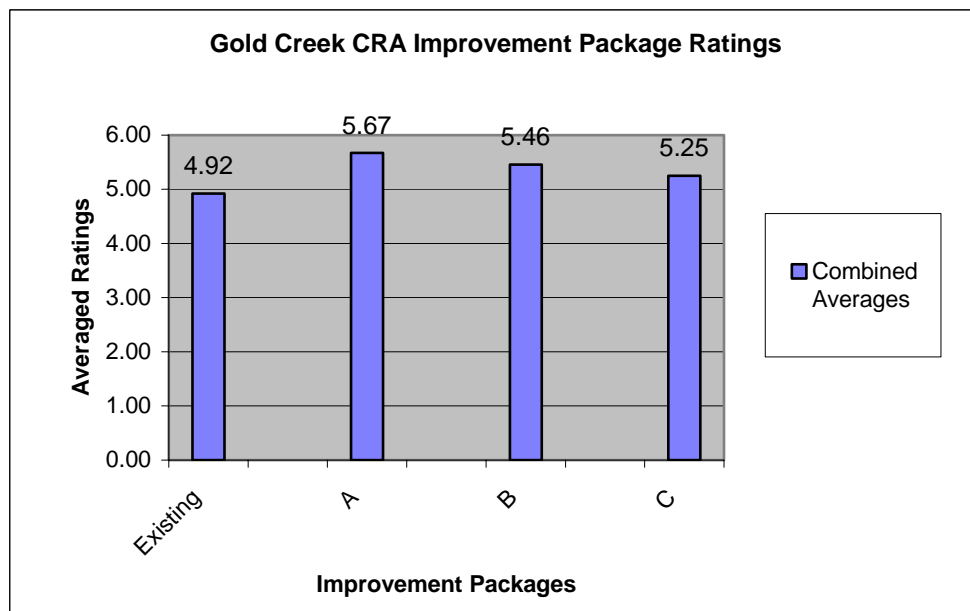
Figure 97 Landscape Unit 1 – Comparison of Improvement Packages – Views from the Road

At Gold Creek, Improvement Package A has the highest visual quality rating because the longer bridges and the removal of roadway fill will allow an increased area for revegetation. The use of the Architectural Guidelines in the design of the bridges and retaining walls will provide for corridor continuity and will make them more memorable.

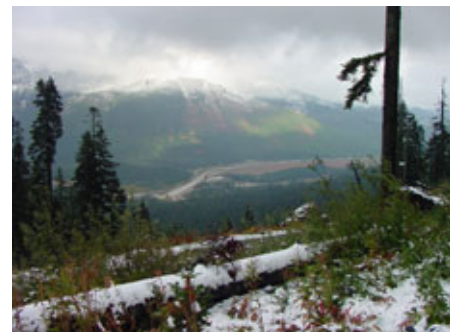
Figure 99 Key View A

The ski slopes have a distant view of the Hyak area and the beginning of the project. The highway is in the background of this view. All alternatives propose increasing vegetation from the current state to blend the highway with its surroundings. The Gold Creek Improvement Package A will allow the greatest opportunity for vegetation, so it has the highest visual quality rating. All options increase visual quality from the

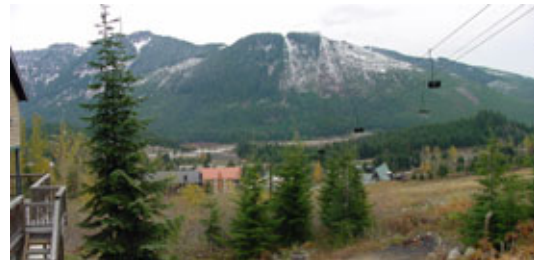
Figure 100 Key View B

From this viewpoint, the highway is in the middleground and is seen as a thin line. The landform rating is very high and would remain so after project completion. Development at Hyak is the principle encroachment in this view and would not change with any I-90 alternative.

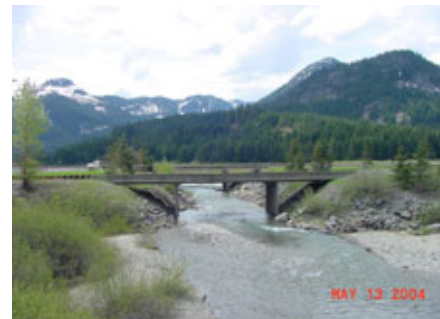
Figure 101 Key View C

From this viewpoint on FS road 4832, the twin bridges over Gold Creek are in the middleground. Improvement Package A proposes twin single-span bridges approximately 120 feet long west of this location. Improvement Package A also proposes two parallel multi-span bridges across the channel migration zone, which replaces the bridges in Key View C. These bridges would be approximately 900 feet long in the westbound direction and 1100 feet long in the eastbound direction. The removal of roadway fill and the opportunity for riparian and wetland vegetation to establish under the bridge and on either side of the bridges would increase visual quality

ratings for vegetation and water. The use of the Architectural Guidelines at this location is especially important because of its high visibility from FS Road 4832.

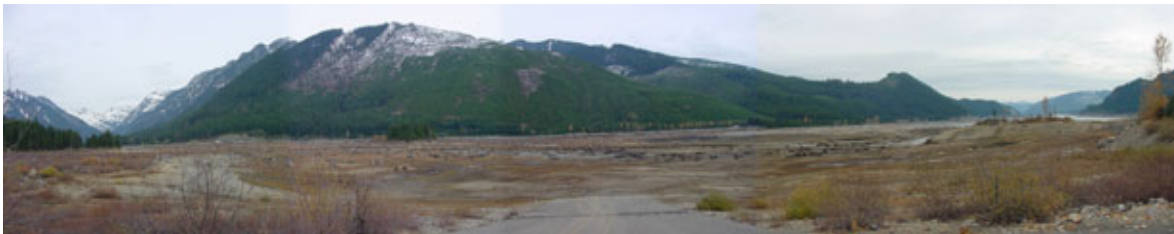
Figure 102 Key View D

The view of I-90 from this Key View is of a horizontal line through the middleground. Retaining walls are proposed, where necessary, along the lake, to support I-90. These will be designed using the Architectural Guidelines. From this location, I-90 will remain in the middleground. Vividness, intactness, and unity ratings are slightly higher than existing conditions after construction of any of the alignment alternatives because of proposed increase in vegetation between the highway and the lake and because the long expanse of bare shoreline will be replaced by a retaining wall.

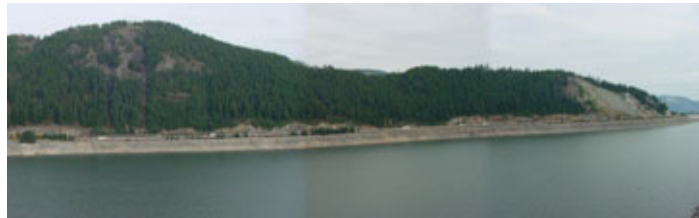
Any changes, such as tunnel entrances or roadside restoration, will affect this view more than the other Key Views along John Wayne Trail, because this is one of the narrower areas of the lake. The snowshed will be removed in Alternatives 2, 3, and 4. The proposed bridge in front of the snowshed location will be visible from Key View H. The use of the

Figure 106 Key View H – Across from Snowshed

Architectural Guidelines for this bridge will be important to visual quality from this view. The snowshed may, or may not remain in this alternative. Because of the Keechelus Lake snowshed's status as an historic feature, coordination with the State Historic Preservation Officer (SHPO) will be required to determine its future.

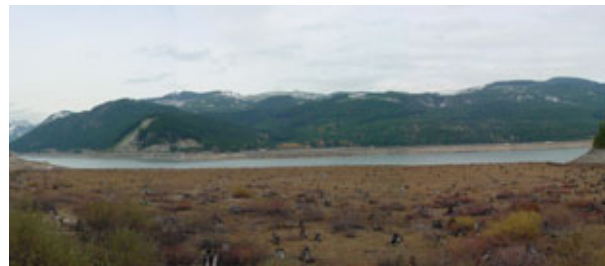
Figure 107 Key View I

From this view, the eastern tunnel portals will be seen, along with the Resort Creek CRA options associated with each Keechelus Lake Alignment Alternative. Changes to the Resort Creek area can provide the opportunity for increased vegetation on the delta formed by the creek and under and around bridges. Any avalanche fencing or rockfall netting will not

be visible from this distance, but significant new rock cuts may be visible.

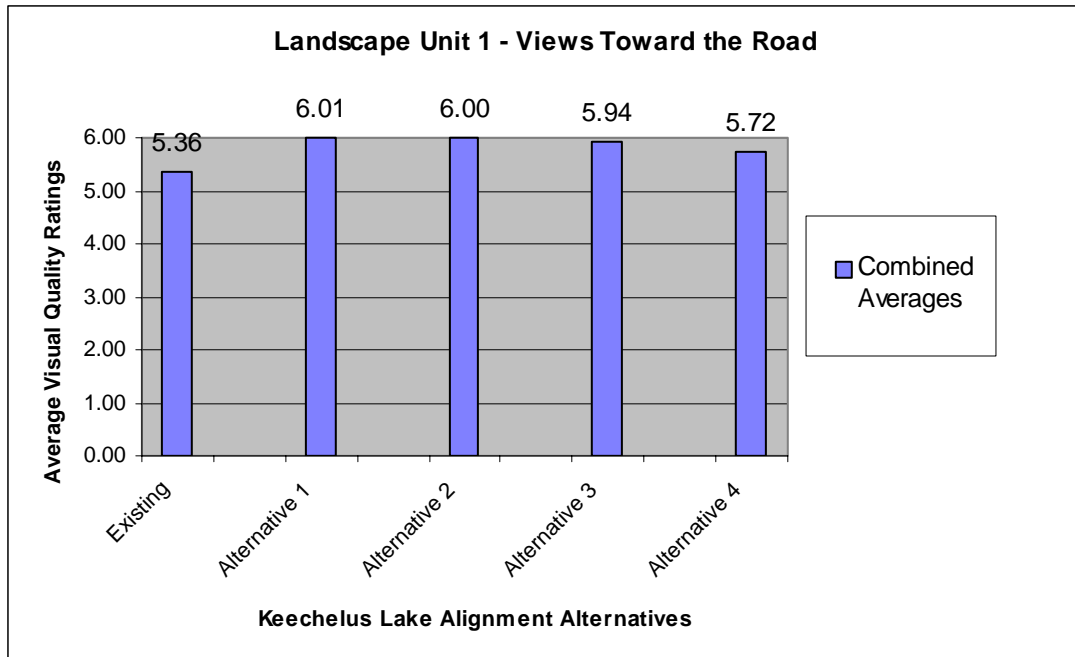
Figure 108 compares the averages of the visual quality ratings for each of the Keechelus Lake Alignment Alternatives. Ratings from Key Views F, G, H, and I were used to analyze views of the alignment alternatives. Alternatives 1 and 2 have virtually the same visual quality ratings from across the lake. The increase in vegetation offsets the increase in development when seen from a distance. Alternative 3 also proposes increasing vegetation between the roadway and the lake, but to a lesser degree than Alternatives 1 and 2. This is reflected in the ratings.

Figure 108 Landscape Unit 1 – Average of Visual Quality Ratings – Views Toward the Road

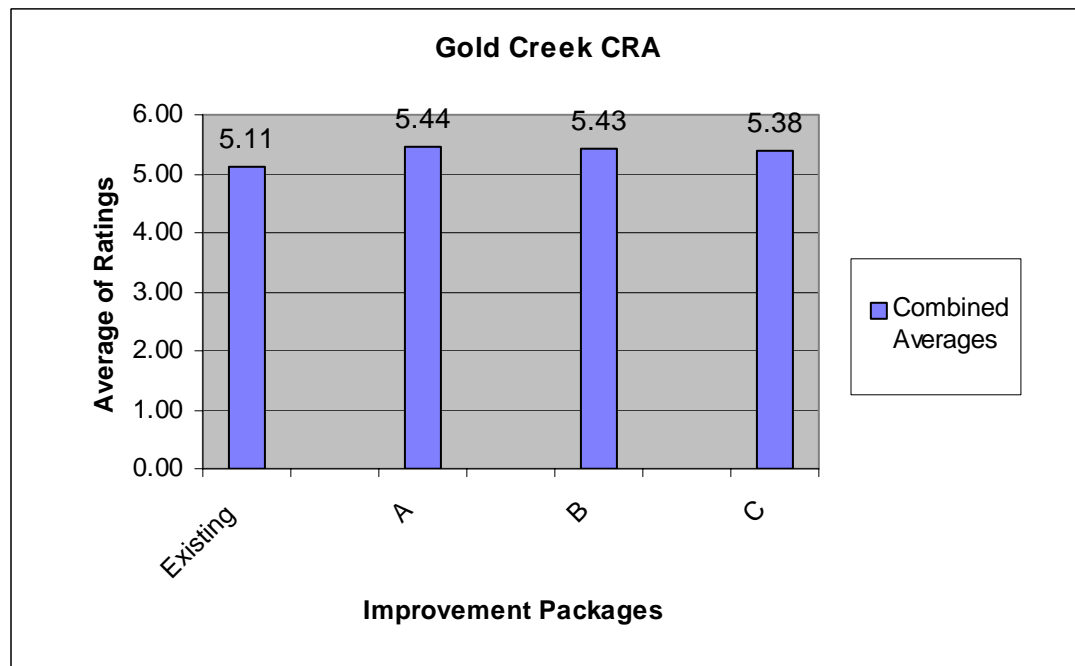
Key Views A, B, and C, with views toward Gold Creek, provided data to average for the Gold Creek CRA. Improvement Package A has visual quality ratings slightly higher than Improvement Package B or C. This is because the larger bridge spans allow greater opportunity for revegetation, which blends the structure with the surrounding forest. Comparative ratings can be seen in Figure 109. All alternatives in this Landscape Unit have high visual quality ratings, which will be improved by the proposed Build Alternatives.

Figure 109 Landscape Unit 1 – Views Toward the Road – Gold Creek CRA

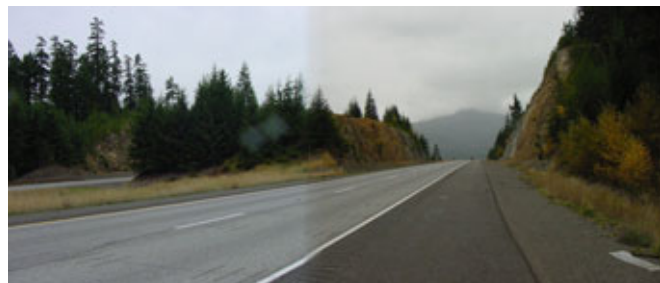
Figure 111 Key View 7

This alternative carries the road in its current horizontal alignment but widens the road to three lanes in each direction. This widening will necessitate removing vegetation and cutting into the rock on either side of the road. The rock island will remain in the median but will be slightly narrower. Slope flattening, slope protection fencing, or rock bolting will be used to minimize rock fall hazards. With revegetation, the vividness and unity ratings are equal to existing conditions.

Key View 7 – MP 60.75 – Westbound – Total Visual Quality Ratings	
<i>Alternatives</i>	<i>Rating</i>
Existing (No Build)	4.67
Build Alternatives	4.67

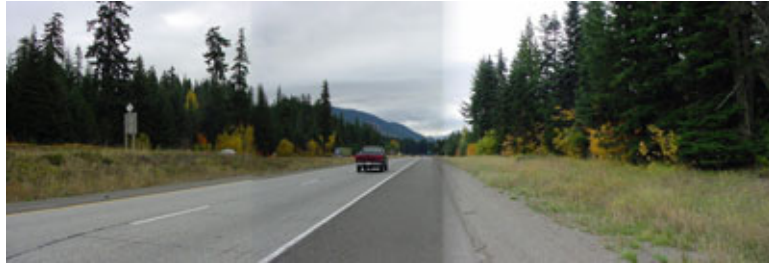
Figure 112 Key View 8

This location has a grassy median and a wide, grassy shoulder with a mixed-age forest beyond. Improvement Package A proposes twin single-span bridges in the vicinity of MP 60.9. At Price and Noble Creeks, twin multi-span bridges, approximately 800-feet long are proposed at mileposts 60.9, 61.4, and 61.7. Improvement Packages A and B propose closing the Sno-park and restroom facilities, including removing pavement and revegetating that area.

Improvement Package B has the same elements as Improvement Package A, but does not include the bridges to the east located at MP 61.7. With the use of the Architectural Guidelines on bridge rails, this alternative will have visual impacts equal to Improvement Package A.

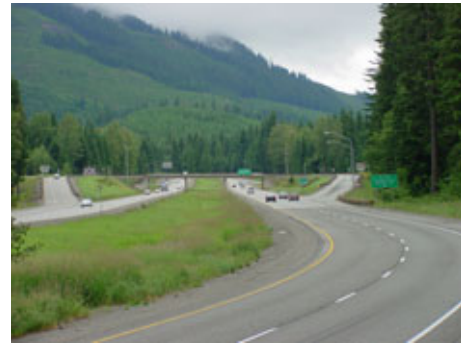
Figure 113 Key View 9

Improvement Package A proposes to change the profile of I-90 so that it passes over the road to Stampede Pass. Twin multi-span bridges are proposed at the west end of the interchange. A twin single-span bridge is proposed at the east end of the interchange. Since the road will pass over these bridges and there is a slight curve to the roadway, it will be important to design the bridges and railings using the Architectural Guidelines. The change in the profile of the highway, removing the current bridge over I-90, significantly improves the visual quality at this Key View.

Improvement Package B proposes a bridge over I-90 at the Stampede Pass Interchange, which will be very visible, and twin single-span bridges at either end of the onramps and additional single-span bridges west of Swamp Creek. Because the bridge over I-90 is one of the more visible bridges, the use of the Architectural Guidelines will be critical at this location. The Architectural Guidelines should also be used for bridge rail design for all proposed bridges.

Ratings for Improvement Packages B and C are above those of the existing condition because of the use of the Architectural Guidelines on the bridges and offsetting roadside restoration. Total visual quality would be moderate to moderately high for these two Improvement Packages. Improvement Package A will improve the visual quality of this vicinity most by putting the I-90 over the road to Stampede Pass, and taking it and its associated slopes out of the view from I-90.

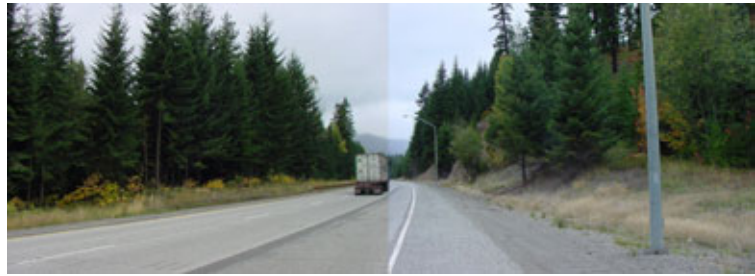
Figure 114 Key View 10

Twin single-span bridges will allow an unnamed creek to flow under I-90. This location currently has mature Douglas firs growing in the median. These provide a dense visual screen between eastbound and westbound lanes of traffic, and make this a pleasant portion of roadway to travel through. The median width will be decreased slightly at this location. There are currently luminaires at the end of the on ramp in this view.

Improvement Packages A and B are the same for this CRA. They propose twin single-span bridges, approximately 120 feet long west of this view. There would also be twin bottomless culverts at Toll Creek. The use of the Architectural Guidelines on structures is critical to visual quality at this location.

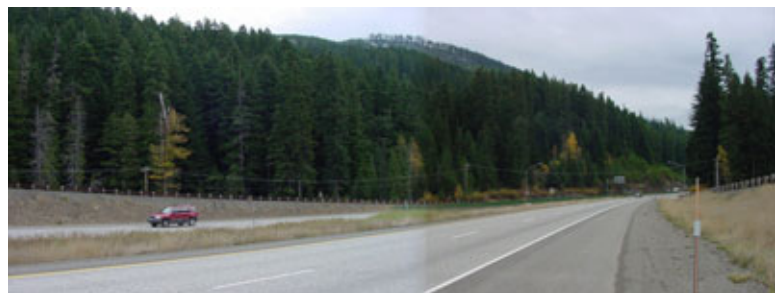
Figure 115 Key View 11

This view is of the on and off ramps for Cabin Creek Road and the I-90 eastbound lanes. Improvement Packages A, B, & C all propose installing twin bottomless culverts just beyond the end of this onramp at Toll Creek. To avoid impacts to the Cabin Creek Sno-park, the road

will be moved slightly to the north. This will result in some cut slopes along the westbound off ramp. Because this will remove some trees, it will decrease the visual quality at those points. Planting shrubs and trees along the roadside can help minimize visual impacts. The use of the Architectural Guidelines on any railings will provide corridor continuity. Visual quality ratings after project completion are expected to be slightly lower than the existing condition.

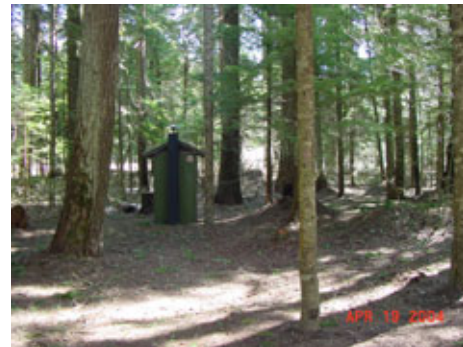
Figure 116 Key View J

There are numerous deciduous shrubs between the campground and the highway that would screen the views during the summer and early fall months. The project raises the profile of the highway 20 to 25 feet, supported by retaining walls. The height of the walls depends on the Bonnie and Swamp Creeks CRA options chosen. Screening vegetation will be planted at the base of these walls to blend them into their surroundings. Because the higher profile will be to the northeast of this view there may be some shading impacts during the morning hours in the buffer between the highway and the forest. Improvement Package B proposes a single-span bridge to the right of Key View J. This will decrease ratings for development for Improvement Package B. Planting shade tolerant evergreen trees and shrubs along the project edges can increase the screening of the road from the campground. Shading issues are not anticipated to impact the campground itself. Increased use of evergreen species may help slightly to provide a psychological buffer for noise.

Key View J – MP 62.50 – Bonnie Creek CRA – Crystal Springs Campground – Total Visual Quality Ratings	
<i>Alternatives</i>	<i>Rating</i>
Existing (No Build)	5.25
Improvement Package A	5.08
Improvement Package B	5.00
Improvement Package C	5.08

Visual quality ratings are projected to be slightly lower than the existing condition because of increased development in the form of retaining walls and the bridge in Improvement Package B.

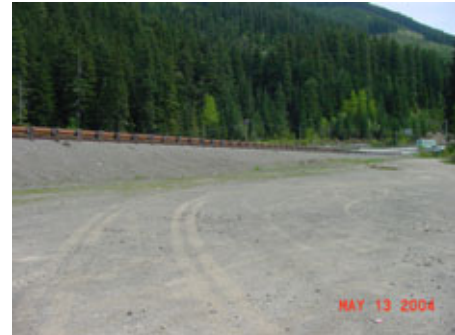
Figure 117 Key View K

This Sno-park is on the southwest side of the on-ramp from Key View 11. Improvement Packages have been described for the Toll Creek CRA. The project will move the roadway away from the Sno-park. Retaining walls are proposed between I-90 and the Sno-park, which may provide an opportunity to plant shrubs along their base as a measure to minimize visual impacts. At present, the foreground view of a gravel parking lot and roadway shoulder has low vividness, intactness, and unity ratings. Although the road profile will be higher, the use of a retaining wall using the Architectural Guidelines will provide corridor continuity.

Key View 11 – MP 64.1 – Eastbound – Toll Creek CRA – Cabin Creek Sno-park – Total Visual Quality Ratings	
<i>Alternatives</i>	<i>Rating</i>
Existing (No Build)	4.67
Improvement Package A	4.71
Improvement Package B	4.71
Improvement Package C	4.71

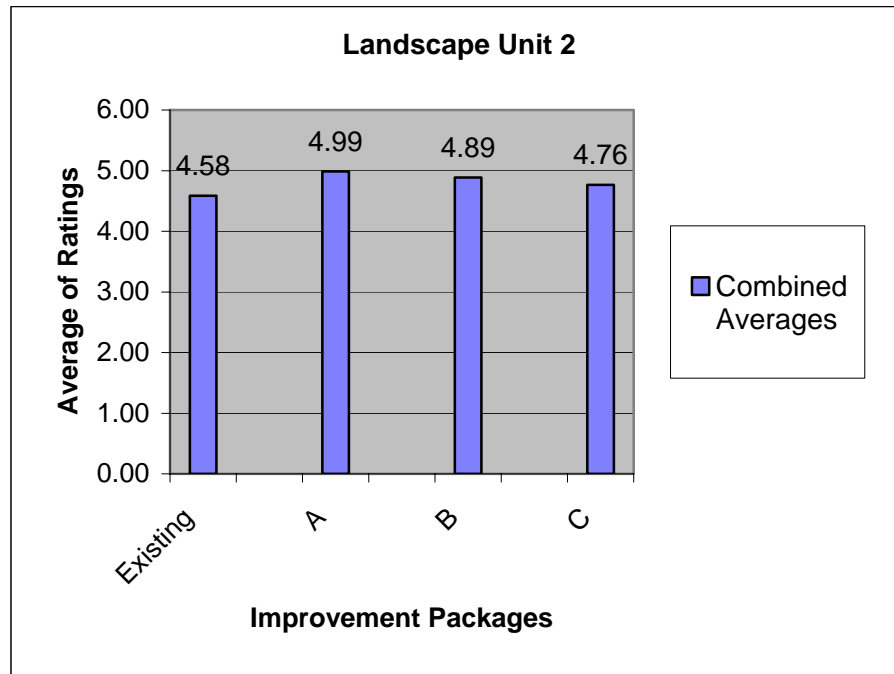
The chart in Figure 118 results from ratings for Key Views 8, 9, 10, 11, and J because they have views of elements addressing the needs at the Price/Noble, Bonnie, Swamp, and Toll Creeks CRA's Improvement Package A has slightly higher overall visual quality ratings because increased opportunity to plant shrubs under and around the bridge openings raises ratings for vividness. More revegetation can take place under and adjacent to a bridge than around a culvert. With the Architectural Guidelines, the bridges will be more memorable and will provide corridor continuity, which also raises ratings for manmade objects, encroachment, and unity. The opportunity to plant trees or shrubs along the base of the retaining wall at the Cabin Creek Sno-park also raises ratings.

Figure 118 Landscape Unit 2 – Price/Noble, Bonnie, Swamp, and Toll Creeks CRA's Visual Quality Ratings

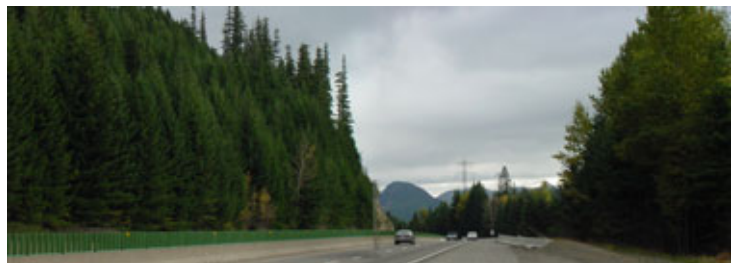
Figure 120 Key View 12

At this location, eastbound travelers will be approximately 10 to 20 feet below the westbound lanes. The median will be wider. It will be necessary to remove trees to the right in this photo. Because of the decrease in screening vegetation, the slope of the land, and the increased visibility of the transmission lines, visual quality ratings decrease slightly. Depressing the eastbound lanes of travel may help

to compensate for the loss of trees to the right in Figure 120. Visual quality is highly dependent on retaining as many large trees to the south of the highway as possible.

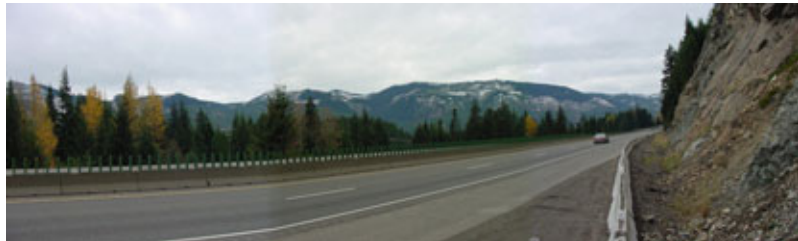
Figure 121 Key View 13

However, the eastbound lanes will be depressed below the westbound lanes so they won't be as visible. From the westbound direction of traffic,

I-90 may actually appear to have less of an imprint than it does at present. The visual impact of the removal of trees, which results in increased visibility of the transmission lines are offset when the eastbound lanes disappear from view. Total visual quality ratings would be equal to the existing condition.

Key View 13 – MP 66.4 - Westbound – Total Visual Quality Ratings	
<i>Alternatives</i>	<i>Rating</i>
Existing (No Build)	4.42
Build Alternatives	4.42

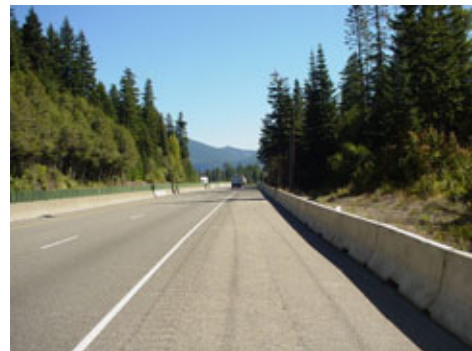
Figure 122 Key View 14

There are three Improvement Package options on this portion of I-90. The highway will be widened to the right in Figure 122, requiring a large area of fill slope, and removal of trees. Improvement Package B would significantly impact this view. B proposes to construct an ecological connectivity structure over I-90, in the form of a vegetated bridge. It will be important to retain as many large trees as possible and to use the Architectural Guidelines on the structure portals or piers.

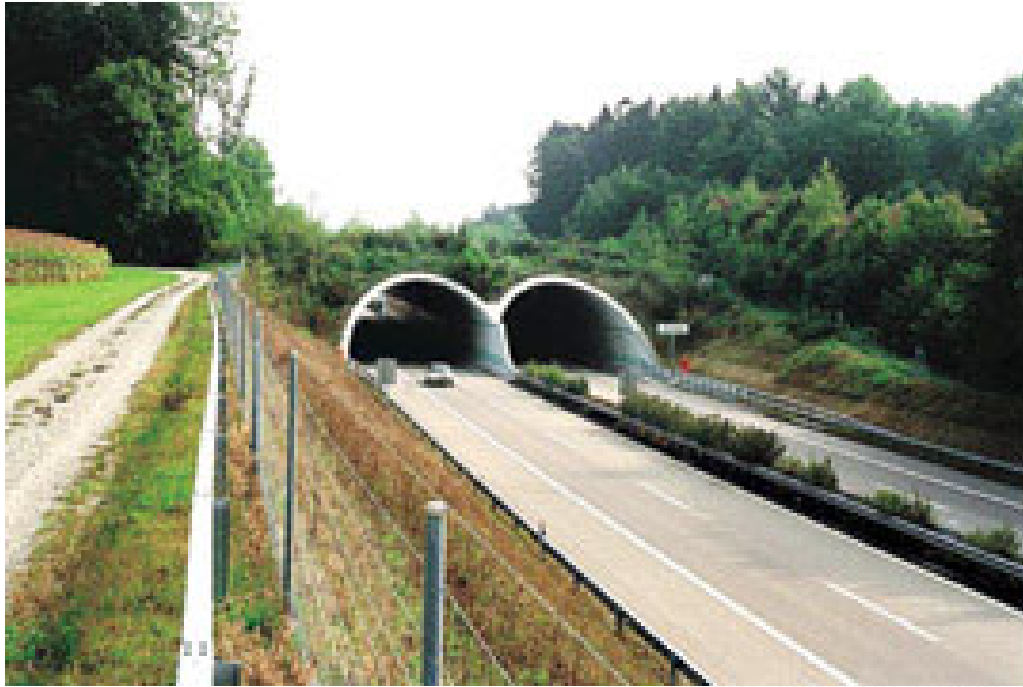
An example of an ecological connectivity structure, often called a "wildlife bride," from Europe is seen in Figure 123. The visual quality ratings assume a vegetated structure designed using the Architectural Guidelines.

Figure 123 Ecological Connectivity Structure in Europe

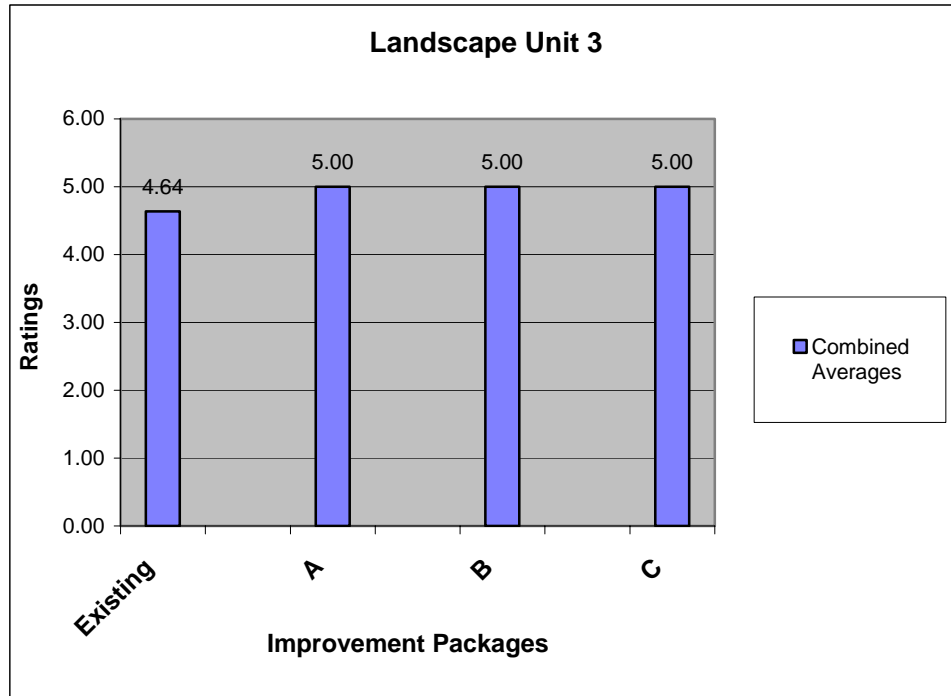
Figure 124 is a chart that graphically compares the averages of the Hudson Creek CRA options at Key View 14. In Key Views 12 and 13, which view only the common alignment, visual quality ratings will be equal to preconstruction ratings due to mitigation measures.

Figure 124 Visual Quality Average for the Improvement Packages in Landscape Unit 3

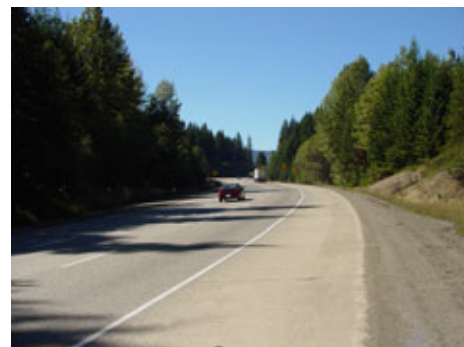
Figure 126 Key View 15

Improvement Package A proposes a bridge under I-90 for wildlife in this vicinity that will be out of view, except for bridge railings, which will be designed using the Architectural Guidelines.

From Key View 15, travelers would see the ecological connectivity structure proposed in Improvement Package B in the background. From this distance, the ecological connectivity structure in option B would not encroach on the view. At this location, I-90 will be shifted to the left in the photo to straighten out the curve.

While there will be an increase in development and the removal of trees in the median, all scores will remain high after project completion, and be equivalent to the existing condition because the Architectural Guidelines will be used to design structures and provide corridor continuity. The project will retain as many large trees as possible and will plant native vegetation on the roadsides. Table 28 shows the ratings for Key View 15.

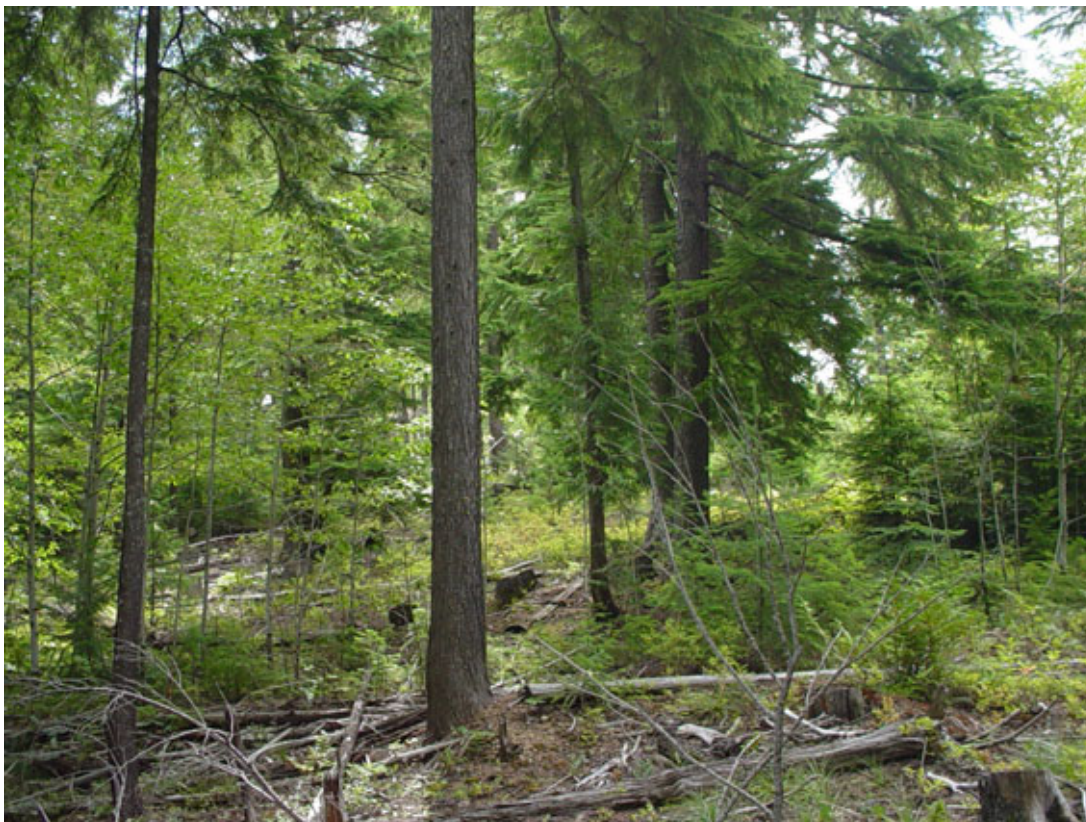
At this location the connectivity restoration option in Package C will be behind the viewer and is described in Key View 17. In all options, the pavement in the foreground will be removed and planted with native vegetation. Trees within the median can be seen in Figure 127.

Figure 127 Example of Second-Growth Trees to be Removed in Median near MP 67.73

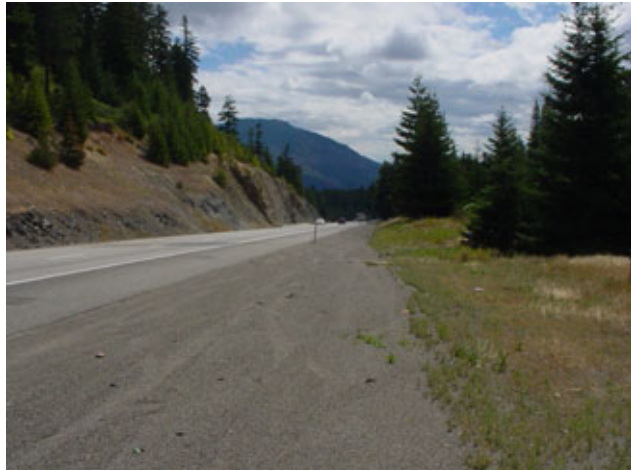
Figure 128 Key View 16

An additional lane will be added and the lanes moved approximately 100 feet to the right in this photo. This will allow for construction of a bridge under the roadway for a wildlife crossing in a draw that exists there now, just off the picture. Old growth trees are located approximately 150 feet from the outside edge of the right-hand lane. Trees to be removed can be seen in to the right in Key View 16. Trees that will be disturbed are generally small in diameter. However, there are some larger, old growth trees just beyond the projected edge of the eastbound lanes. They should be retained, and protected during construction, if possible. Views from this viewpoint may be enhanced if the viewer can see the old growth trees in a healthy condition. This section of second growth forest can be seen in Figure 129.

Improvement Packages A and C propose a single-span bridge, approximately 120 feet long in this vicinity of Key View 16. Bridge railings should be designed using the Architectural Guidelines for this project to enhance corridor continuity. Improvement Package B proposes no structures in the vicinity of this view. Visual quality ratings are currently high and after project completion they should be equal to current ratings and may be enhanced by the improved view into a higher quality forest.

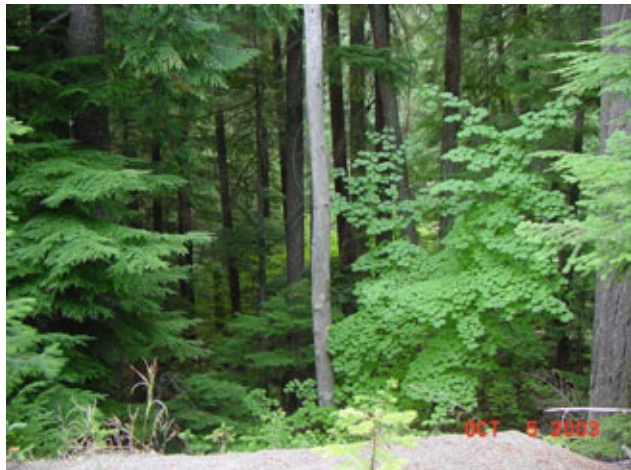
Figure 129 MP 67.7 Vicinity – Potential View into Forest

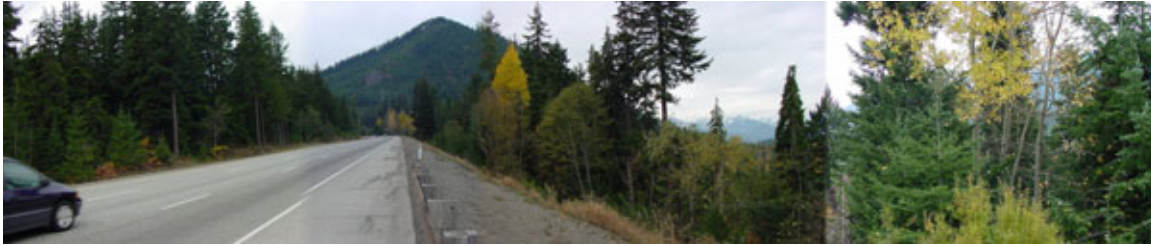
Figure 130 Key View 17

At this location, the westbound alignment would be moved south, to the left in this photo, into the median edge, as described in Key View 15. Improvements in Packages A and B are beyond the curve ahead at MP 67.5. Improvement Package C proposes a wildlife bridge over I-90 and MP 67.7 that will be visible in the middleground from Key View 17. The wildlife bridge will be planted with grasses, trees, and shrubs. Because I-90 is shifted to the left, in this view, the project proposes to restore vegetation on the existing, unused roadbed according to Treatment Level 2 for Forest Classification from the *Roadside Classification Plan*. The structure in Improvement Package C will also be designed using the Architectural Guidelines.

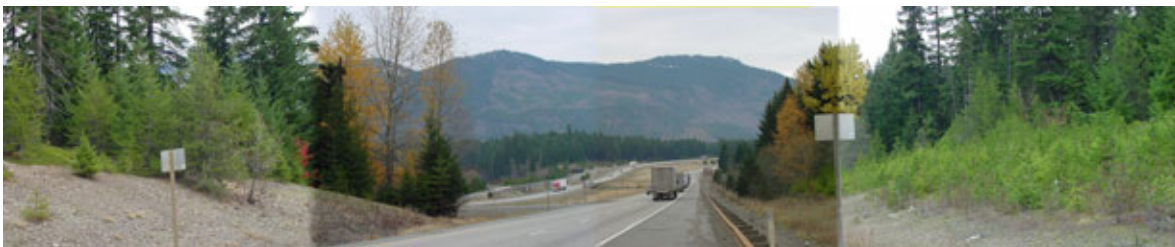
Figure 131 Key View 18

At this point, the median changes from hill to a wide, predominantly grassy area. Highway widening will impact young trees in the median or to the right of the roadway in Figure 131. Most trees in this vicinity are young or stressed. The climate is more arid at the east end of the project corridor than it is at the western end. The Build Alternative at the Kachess River CRA will be visible from this Key View. After project completion and plant establishment, visual quality is expected to be equal to the existing condition.

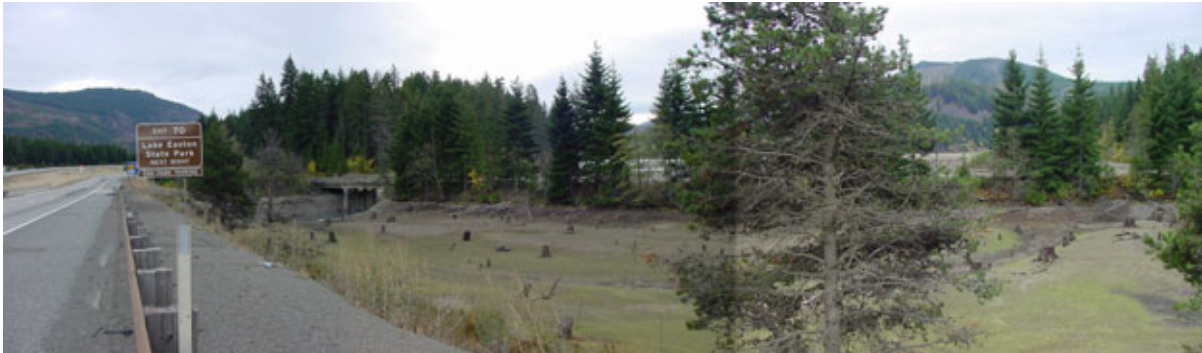
Figure 132 Key View 19

This is a partial view of Lake Easton. (Water levels were low in the Fall of 2001 when the photo in Figure 132 was taken.) The project will widen the bridge over the Kachess River using the Architectural Guidelines for all elements of the bridge. This is a highly visible bridge, as seen in Key View L, Figure 133. After project completion, visual quality ratings will remain equal to the existing condition (see Table 32). Although there will be an additional lane, the use of a consistent design theme on structures and revegetation will provide corridor continuity and make this section of I-90 more memorable.
